NORTHERN CORRIDOR  
TRANSIT AND TRANSPORT  
COORDINATION AUTHORITY

# SURVEY REPORT ON PRIORITY BLACK SPOTS ALONG THE NORTHERN CORRIDOR ROUTE IN KENYA

20 March 2020

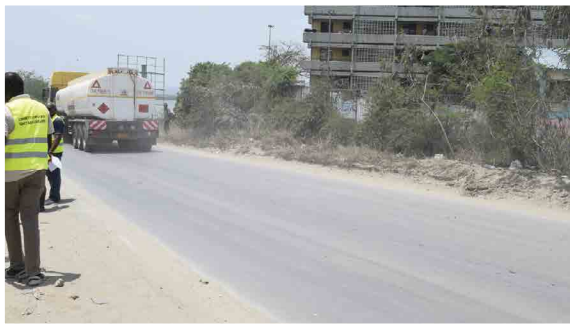
*Figure 2: Missing road markings at Makupa Causeway*

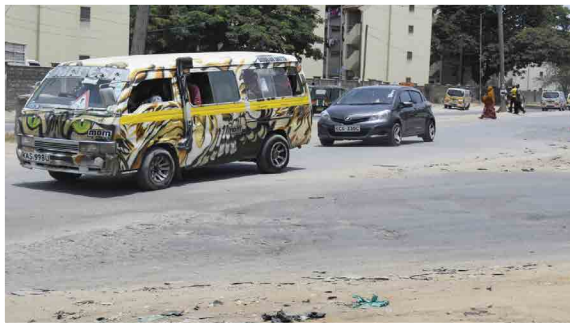
*Figure 3: Deteriorated road surface at Makande Junction*

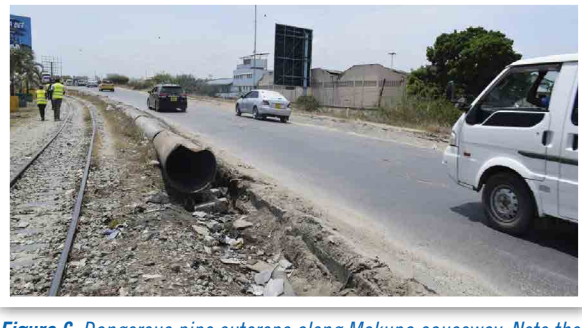
*Figure 6: Dangerous pipe outcrops along Makupa causeway. Note the close proximity between the carriageway and railway line*

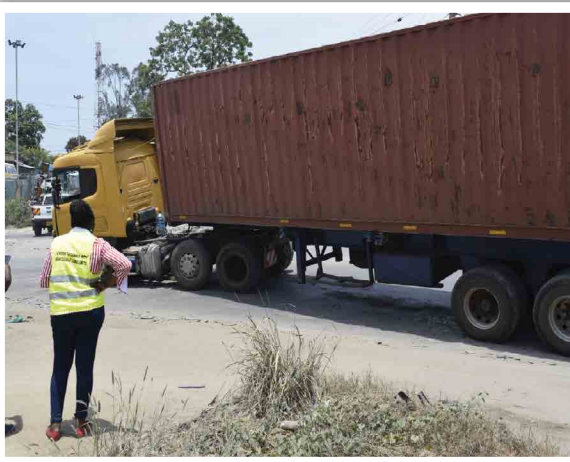
*Figure 4: Insufficient turning radius for heavy trucks at Makande Junction*

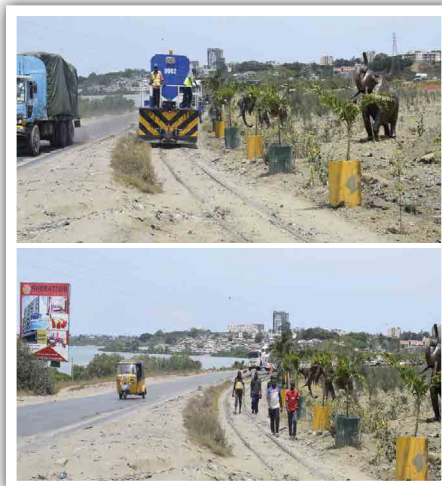
*Figure 7: Absence of a barrier between the road and railway line posing a safety hazard to pedestrians.*

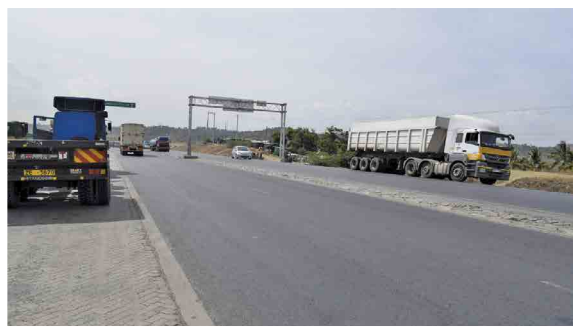
*Figure 8: Faded road markings*

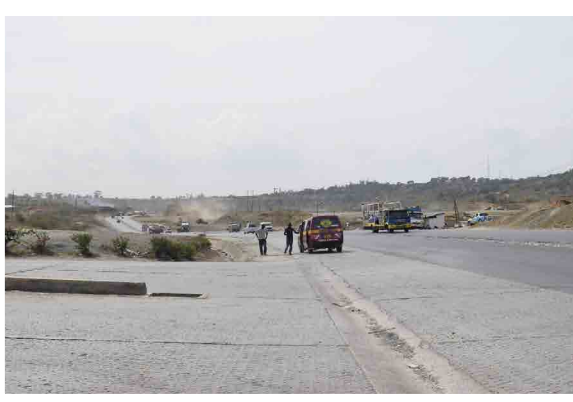
*Figure 10: Picking up/dropping off of passengers at non-designated locations (no provision for a bus bay)*

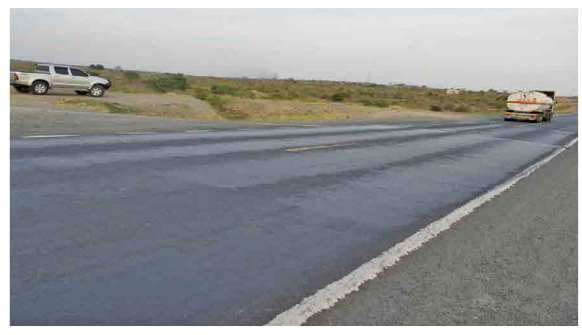
*Figure 11: Bleeding road surface*

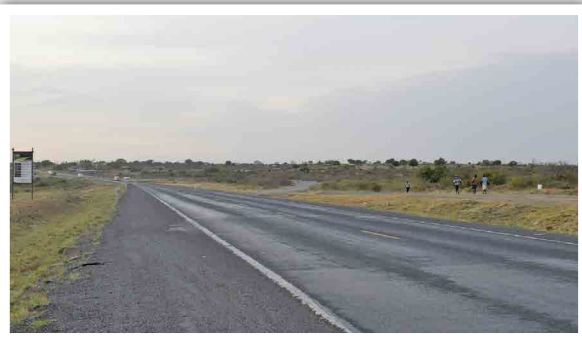
*Figure 12: Deep open drains too close to the carriageway*

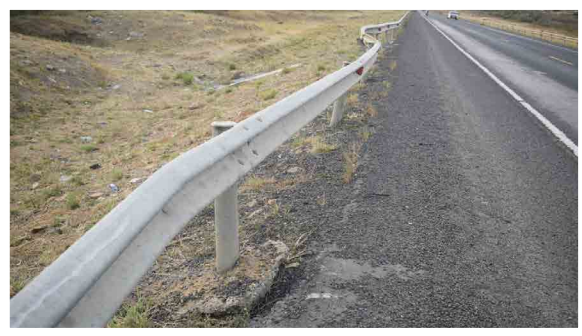
*Figure 13: Damaged safety fences/guard rails*

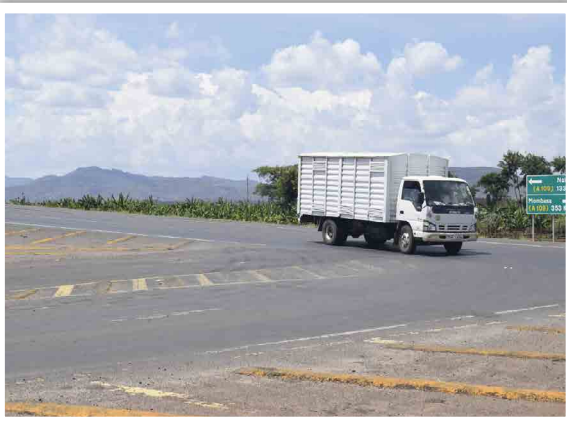
*Figure 15: Lorry exiting towards Oloitoktok from the A8 Highway (note the skid marks indicating difficulties when making the turn)*

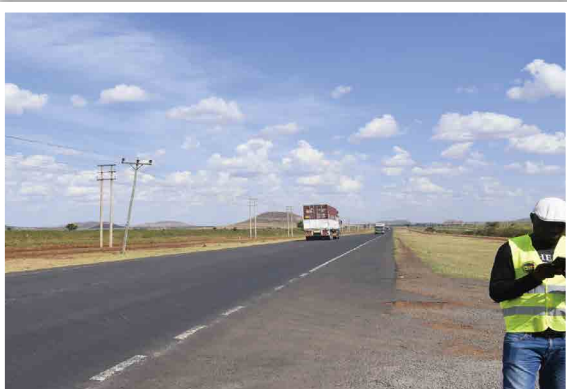
*Figure 16: Long and straight stretch along Pipeline area. Faded road markings at the stretch also observed*

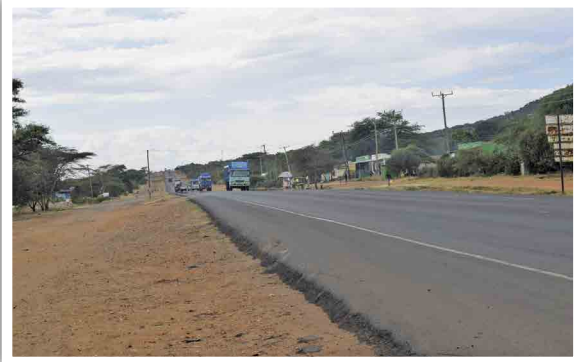
*Figure 17: Kalimbini area (Long and straight stretch with a slight descent from the Nairobi side prompting motorists to overspeed and overtake recklessly)*

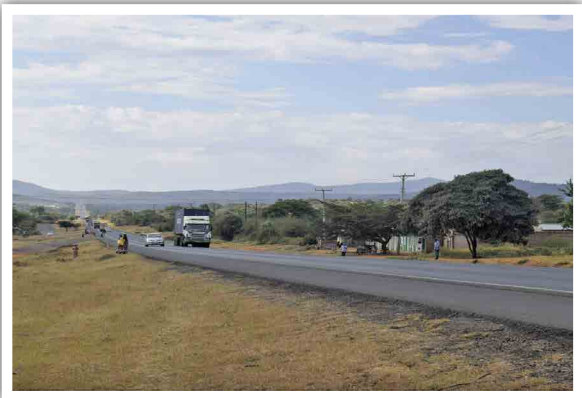
*Figure 18: Ngokomi shopping centre (Long and straight stretch with gently sloping approaches on either side)*

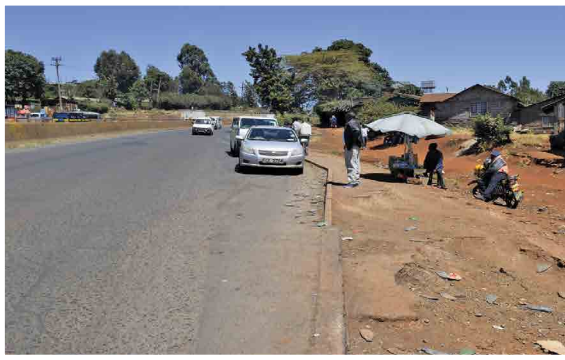
*Figure 19: Dangerous location of the Nairobi bound bus bay*

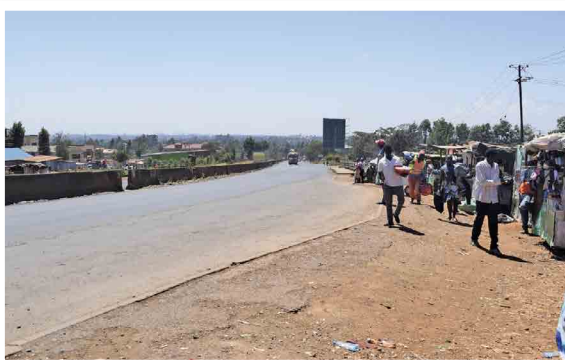
*Figure 20: Encroachment of the road reserve by vendors/hawkers*

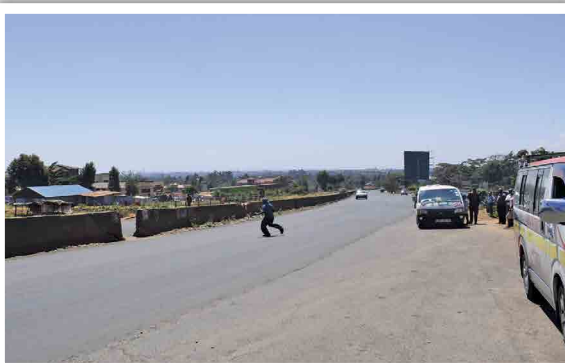
*Figure 21: Rushing pedestrian crossing at a non-designated location*

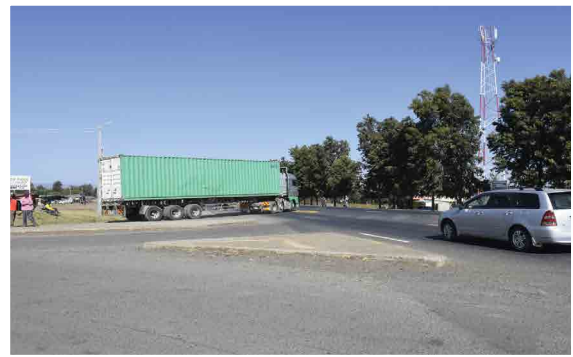
*Figure 22: Heavy truck joining the A8 Highway from Njoro (note the narrow turning radius).*

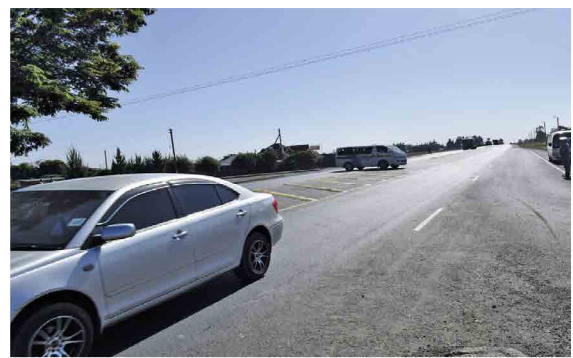
*Figure 23: Matatu joining Eldoret bound traffic from Menengai*

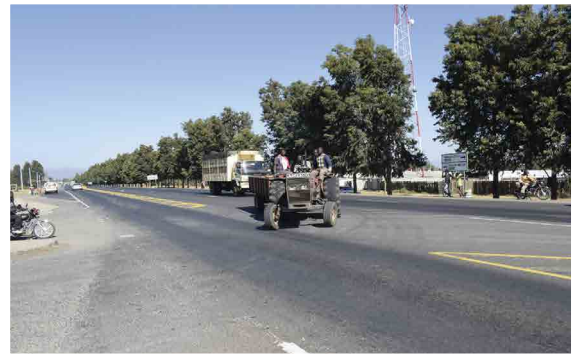
*Figure 24: Lack of a provision for an accelerating lane for Eldoret bound traffic from Njoro*

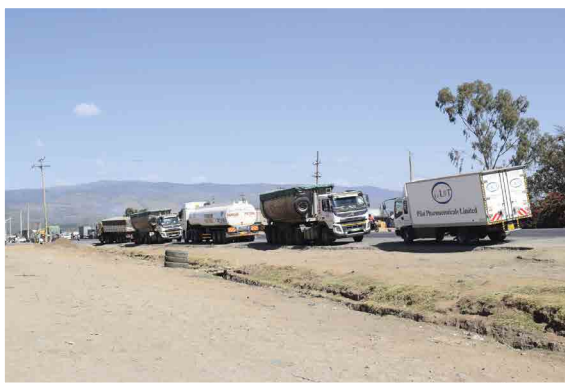
**Figure 25:** Heavy trucks parked on the shoulders effectively narrowing the carriageway and impairing visibility for other road users

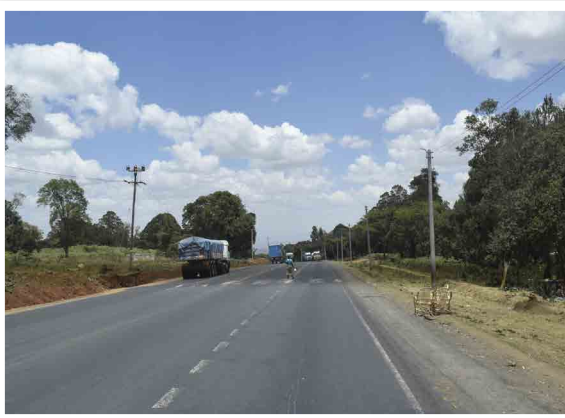
**Figure 26:** Hawkers/vendors selling their products on the carriageway around Sachangwan area oblivious of the safety hazards

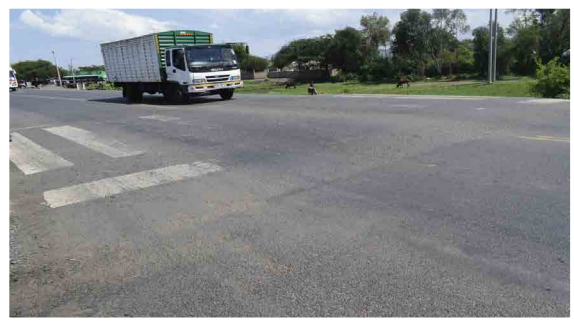
**Figure 27:** Faded road markings at a pedestrian crossing

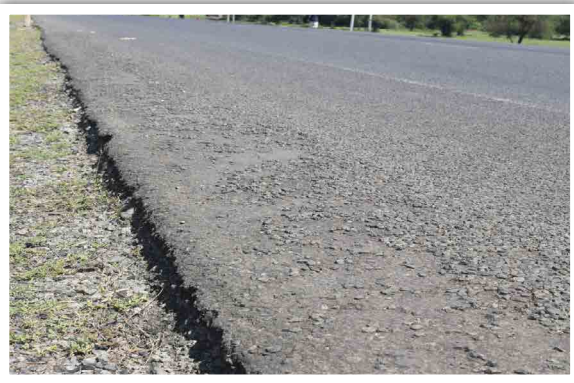
**Figure 28:** Hanging road shoulders

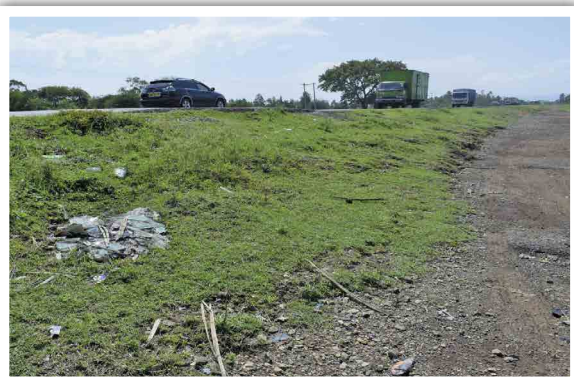
**Figure 29:** Missing safety fences on a high steep-sloped embankment

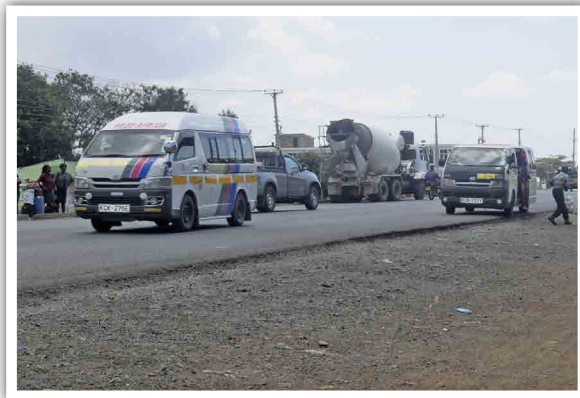
**Figure 30:** Dropping off/picking up of passengers at non-designated locations despite provision for a bus bay a few metres away

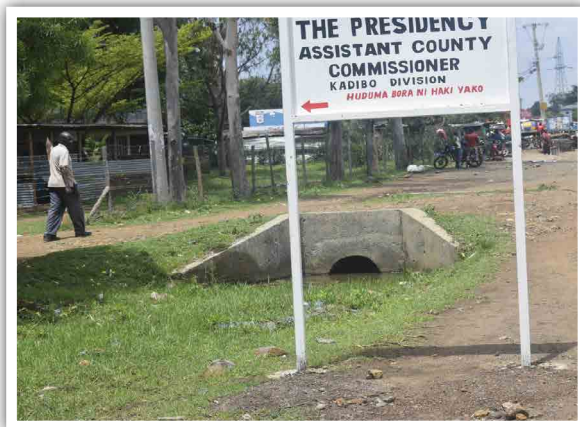
**Figure 31:** Silted/blocked access culvert

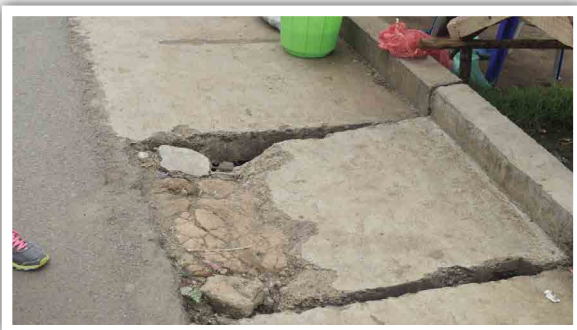
**Figure 32:** Damaged slab over a covered storm water drain

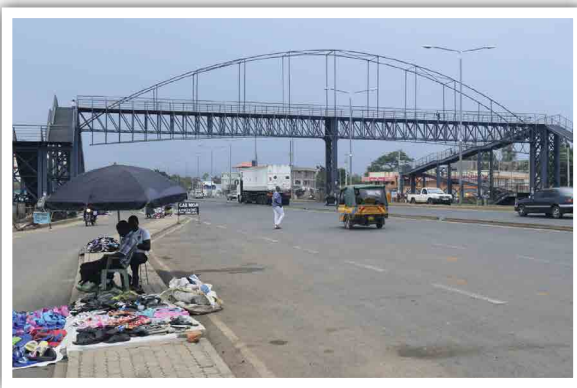
**Figure 33:** Pedestrian dangerously crossing the highway at grade despite provision of a footbridge

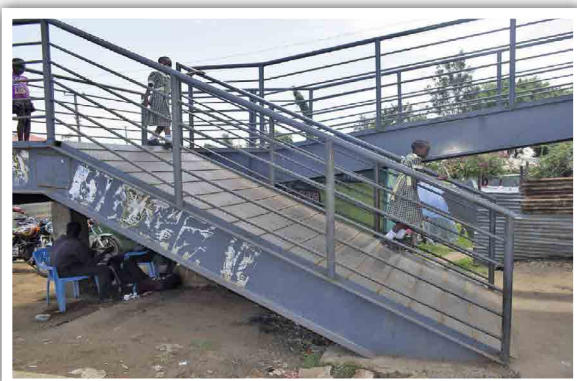
**Figure 34:** An abnormally steep ramp on the footbridge
